Manhole Inspection Summary

Manhole # S35G__030MH

Insp Date: **10/29/08 1:35 PM**

Location Address: **e lombard st**

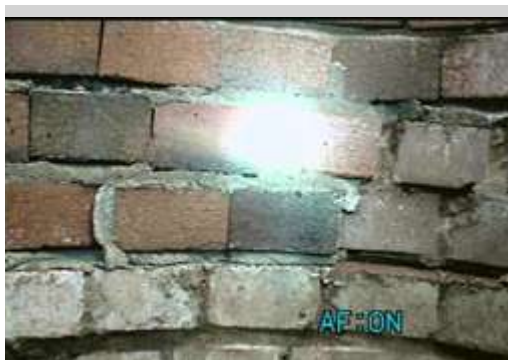
MISCELLANEOUS

Condition: ☐ Sound ☒ **Cracked** ☐ Root Intrusion ☐ Loose Brick ☐ Deteriorated

crack frame adj

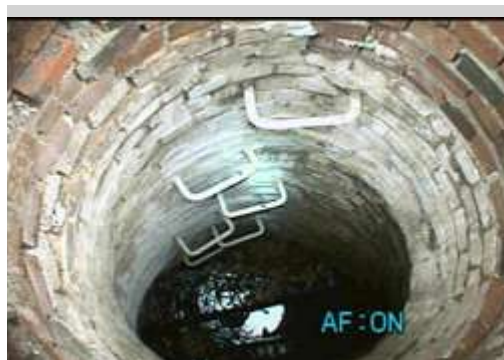
MISCELLANEOUS

cor. steps

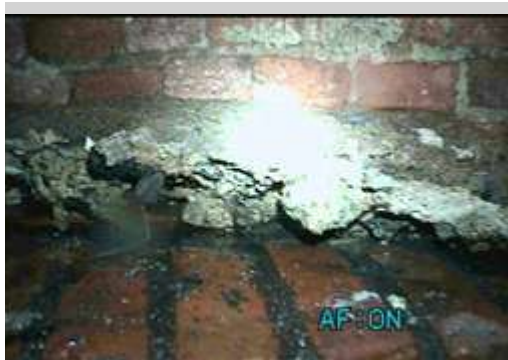
Defect 6

Condition: ☐ Sound ☐ Cracked ☐ Root Intrusion ☐ Deteriorated ☐ Leaks ☒ **Debris**

bench debris

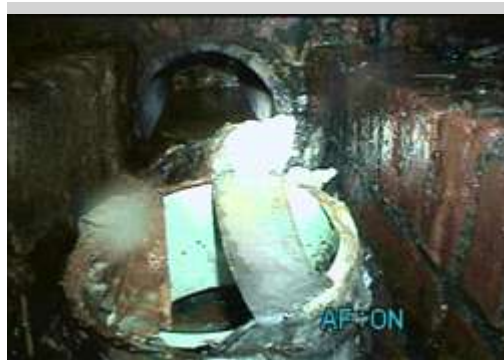
Defect 5

Condition: ☐ Sound ☐ Cracked ☐ Root Intrusion ☐ Deteriorated ☐ Leaks ☒ **Debris**

channel debris

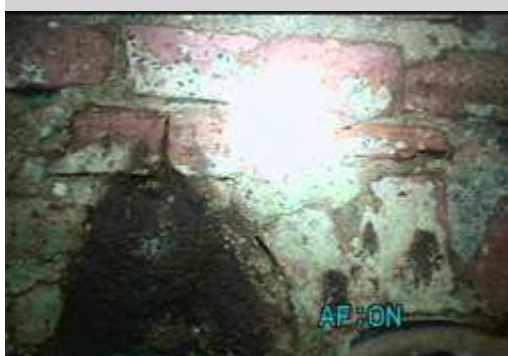
Defect 4

Infiltration: ☐ None ☐ Joint ☐ Cracks ☐ Mortar ☐ Roots ☒ **Wall**

infiltration in barrel

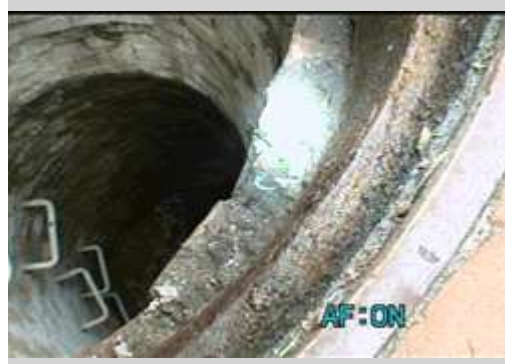
Defect 1

Offset: **2** (in.)

offset
